COUNCIL ASSESSMENT PANEL MEETING

AGENDA – 8.4

Applicant: Kermel Pty Ltd	Landowner: Kermel Pty Ltd
Agent: Greg Burgess - Access SDM	Originating Officer: Ashleigh Gade
Development Application:	20/1058/473 (20/C047/473)
Application Description: Community title division (1 into 11), removal of 1 regulated tree (<i>Corymbia citriodora</i> – Lemon-scented gum) & 2 significant trees (<i>Corymbia citriodora</i> – Lemon-scented gum & <i>Eucalyptus globulus</i> – Tasmanian blue gum) & construction of internal roadway	
Subject Land: Lot Lot:45 Sec: P5126 DP:125856 CT:6249/801 (formerly Lot:54 Sec: P5126 FP:155869 CT:5491/250)	General Location: 29 Kumnick Street, Lobethal SA 5241 Attachment – Locality Plan
Development Plan Consolidated: 8 August 2019. Map AdHi/12	Zone/Policy Area: Township Zone - Township (Lobethal) Policy Area
Form of Development: Merit	Site Area: 1.066 hectares
Public Notice Category: Category 1 Merit -	Representations Received: N/A Representations to be Heard: N/A

The purpose of this application is to create eleven (11) community titled allotments. The proposal includes the removal of one (1) regulated tree (*Corymbia citriodora* – Lemon-scented gum) and two (2) signific

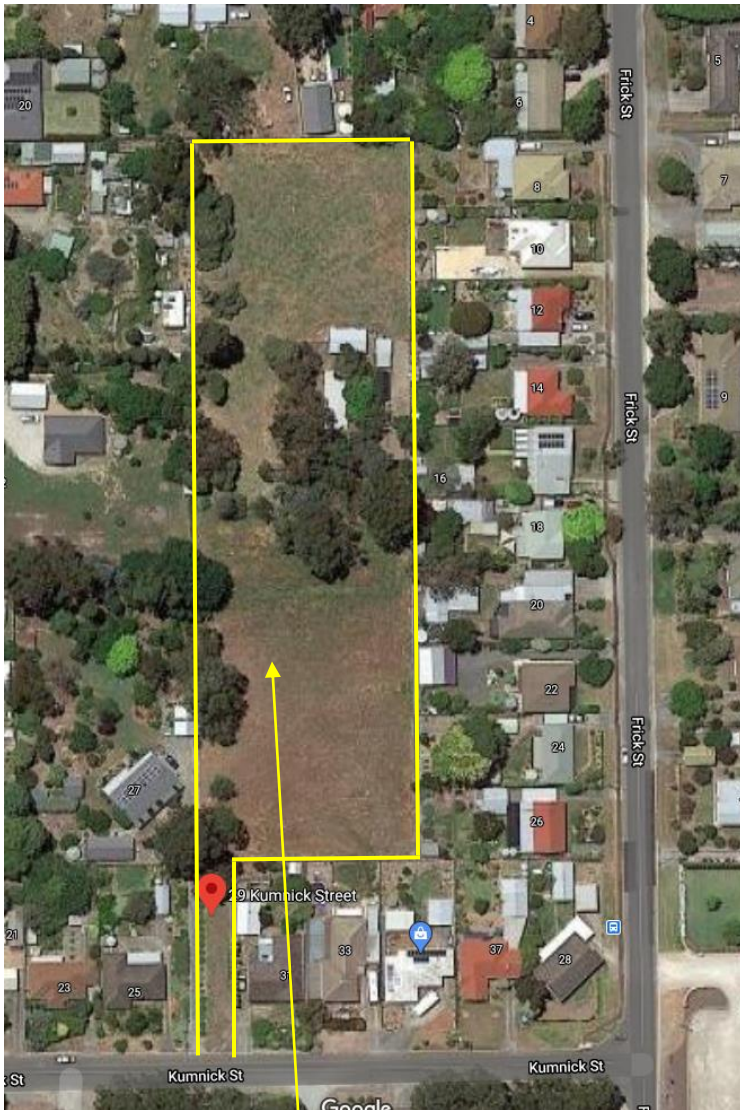
Proposed subdivision area

The main block indicated had many species of trees, *Euc globulus*, *Euc. saligna*, *Casuarina* sp. *Acacia* sp, *Euc camaldulensis*, *Euc. leucoxydon*, *Quercus* sp. and *Melaleuca* sp. Approximately 53 trees. Their condition was very poor to very healthy. Some trees were affected by borers and die-back possibly from South Australia's drier weather conditions. Ages of the trees varied from under 10 years to over 30 years old.

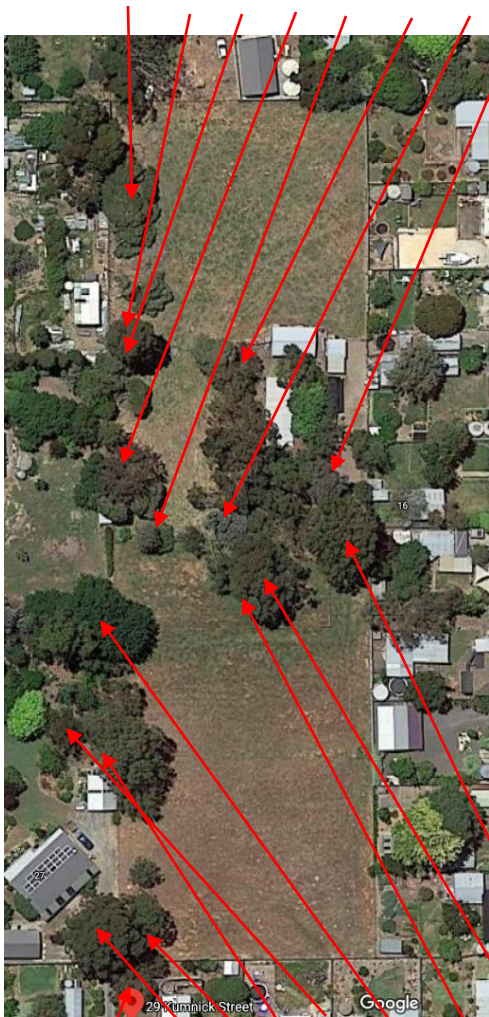
Trees # 23, 24, 25, 27, 28, 38, 30, 21 (These are the approximate location of trees)

Trees # 1, 1A, 2, 10, 11, 12A, 13, 14, 15

- Remove all Melaleuca's as they have decay, splitting or have fallen over.
- Trees numbering 1 to 4, except number 1A, should possible be removed to allow access to development.
- Tree number 15 should have a full report to be removed, if developer requires, as it is significant but has borer activity throughout various areas within the trunk and branches.
- Other trees that are poor in quality that should be removed are numbers 13, 19, 26, 30, 31, 33 and 37.
- There are many smaller trees and shrubs that are under size that should be assessed once boundaries are planned, to see if they remain or removed. The majority of these plants are not tagged.
- Remaining trees should have arborist work on them to maintain their health and safety.
- Significant and regulated trees should have Australian Standard AS4970-2009 applied to maintain their health from the proposed development.

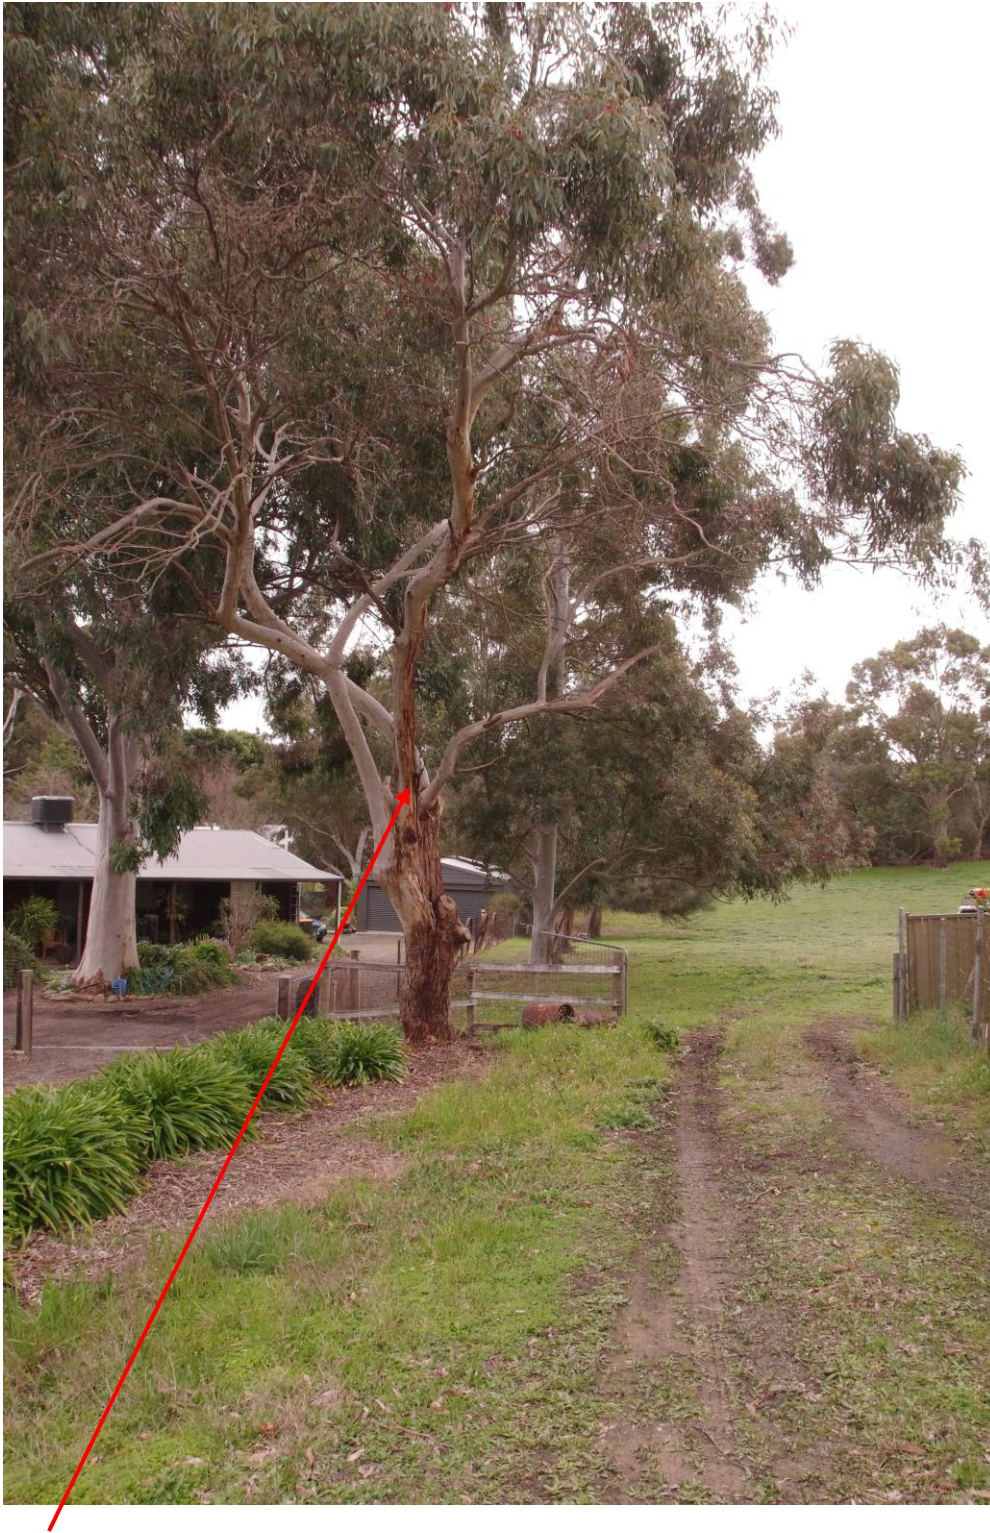
Tree # 1 located before entrance gate off Kumnick Street

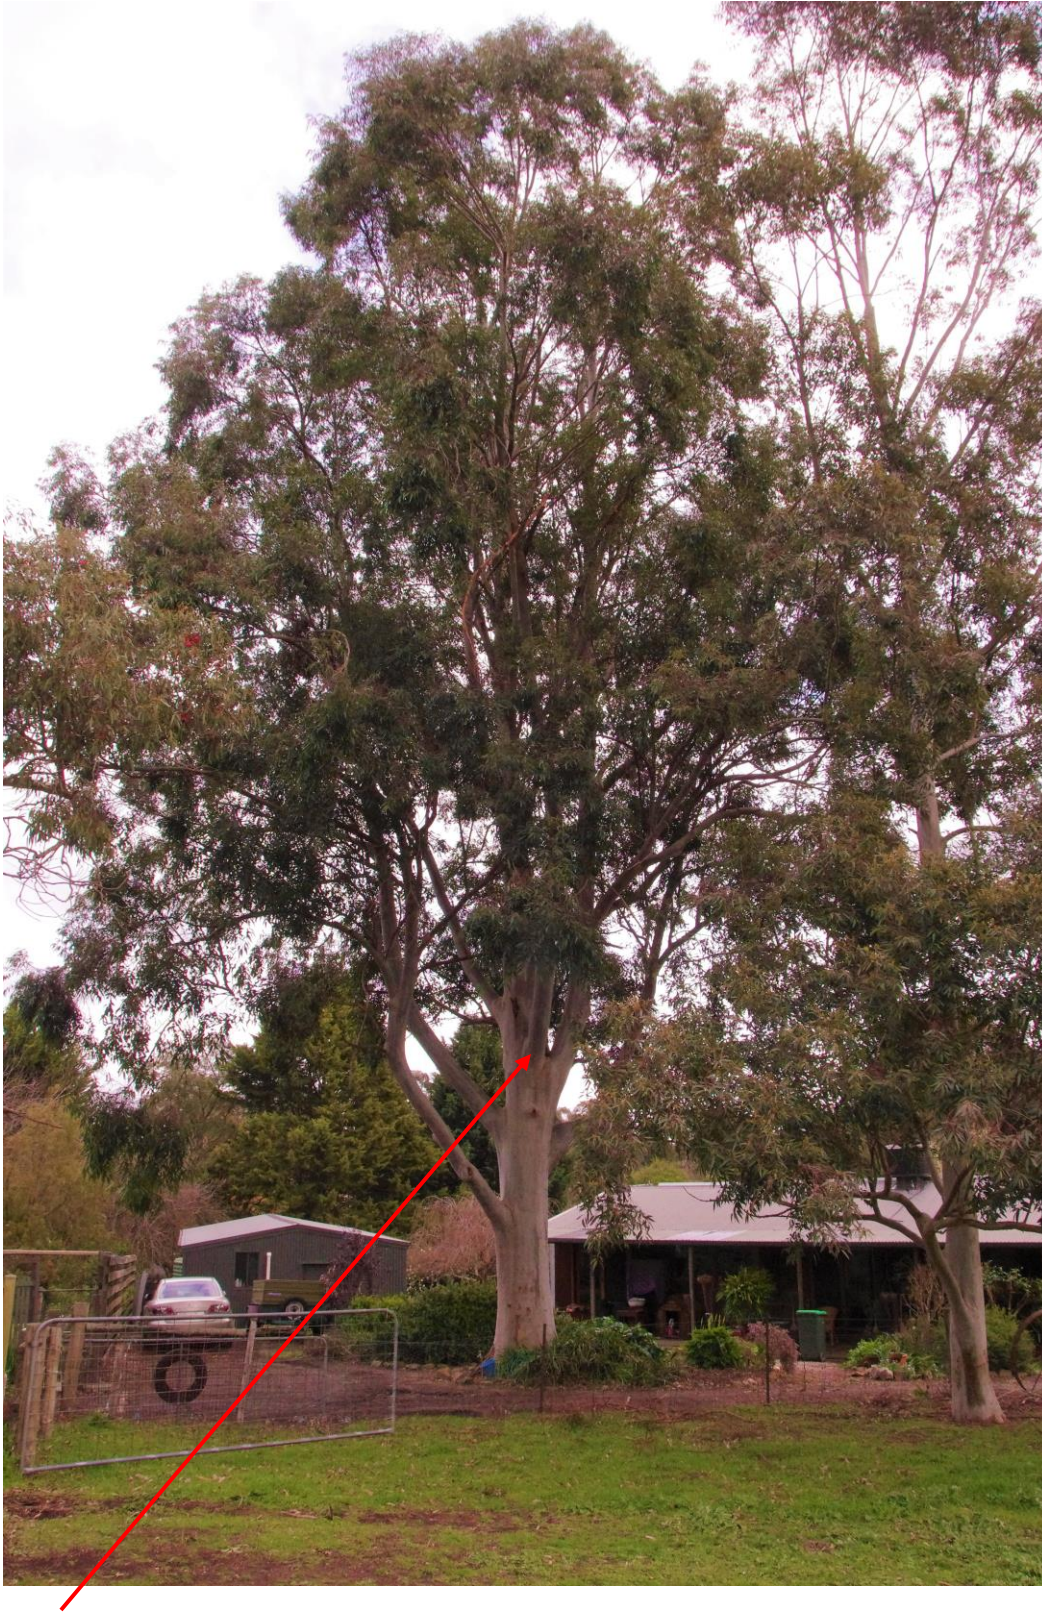
Tree # 1A, neighbouring property and possibility of TPZ intrusion with development. Development 1m inside property at number 29 is approximately 10% intrusion.

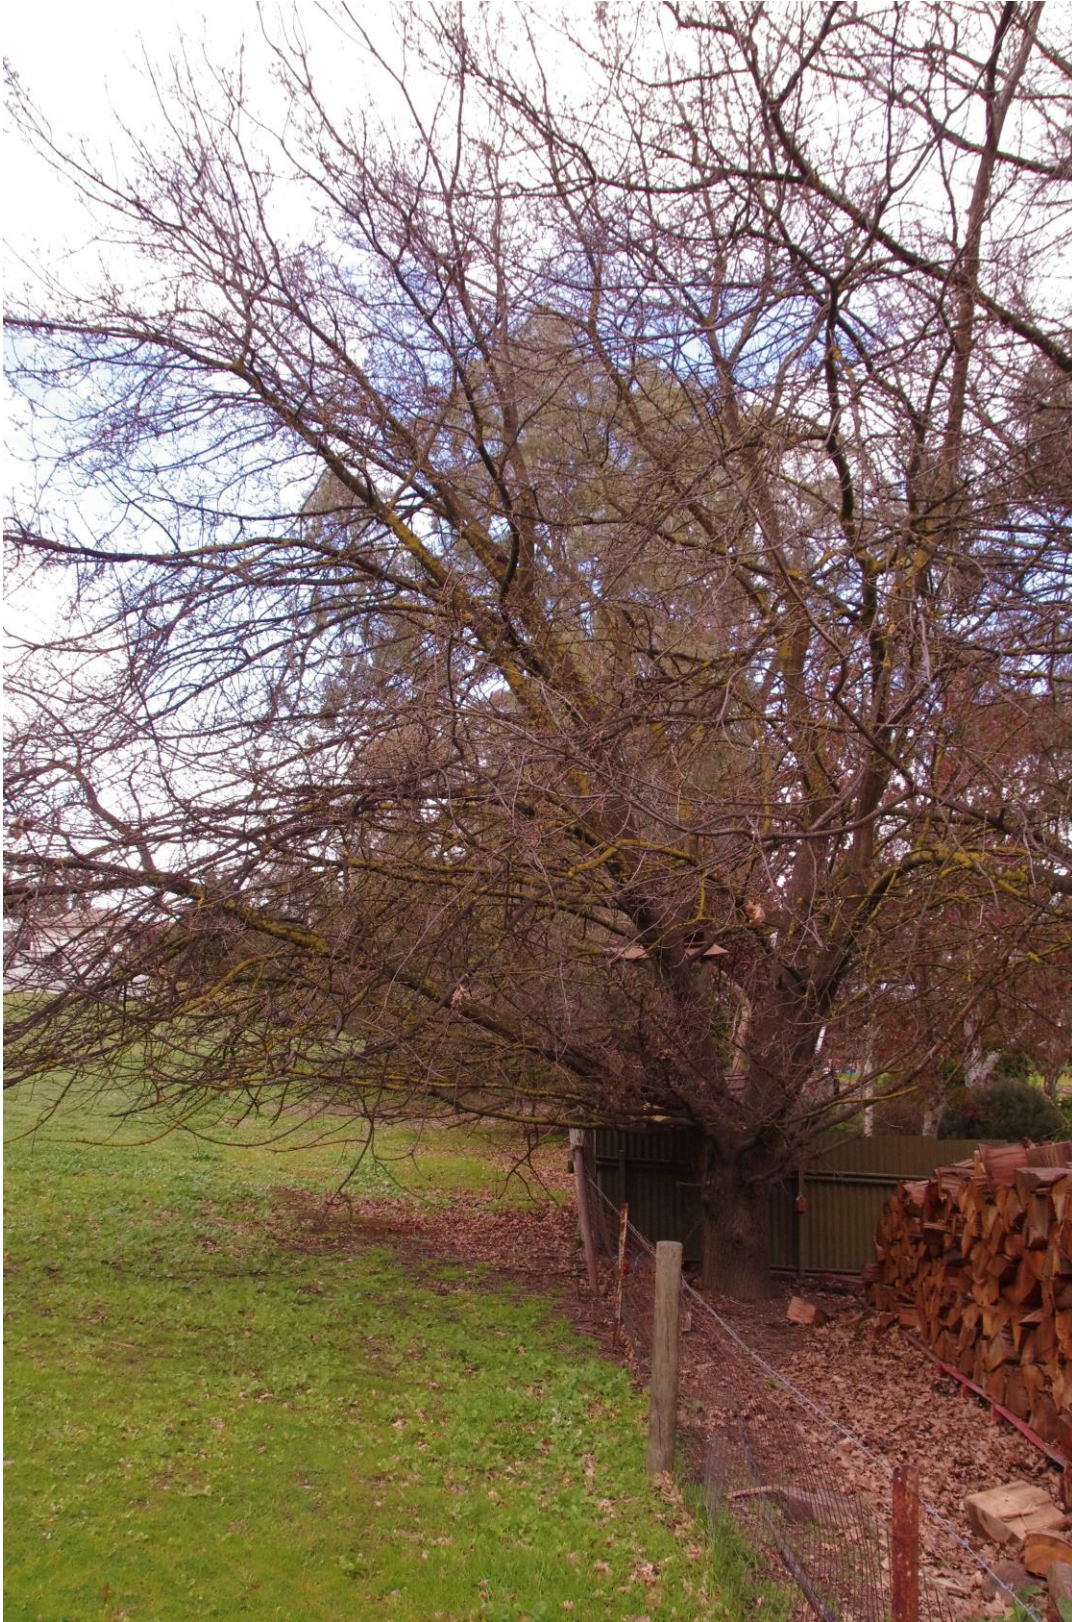
Tree # 13, could be trimmed to allow access for trucks and still retain tree, permission required.

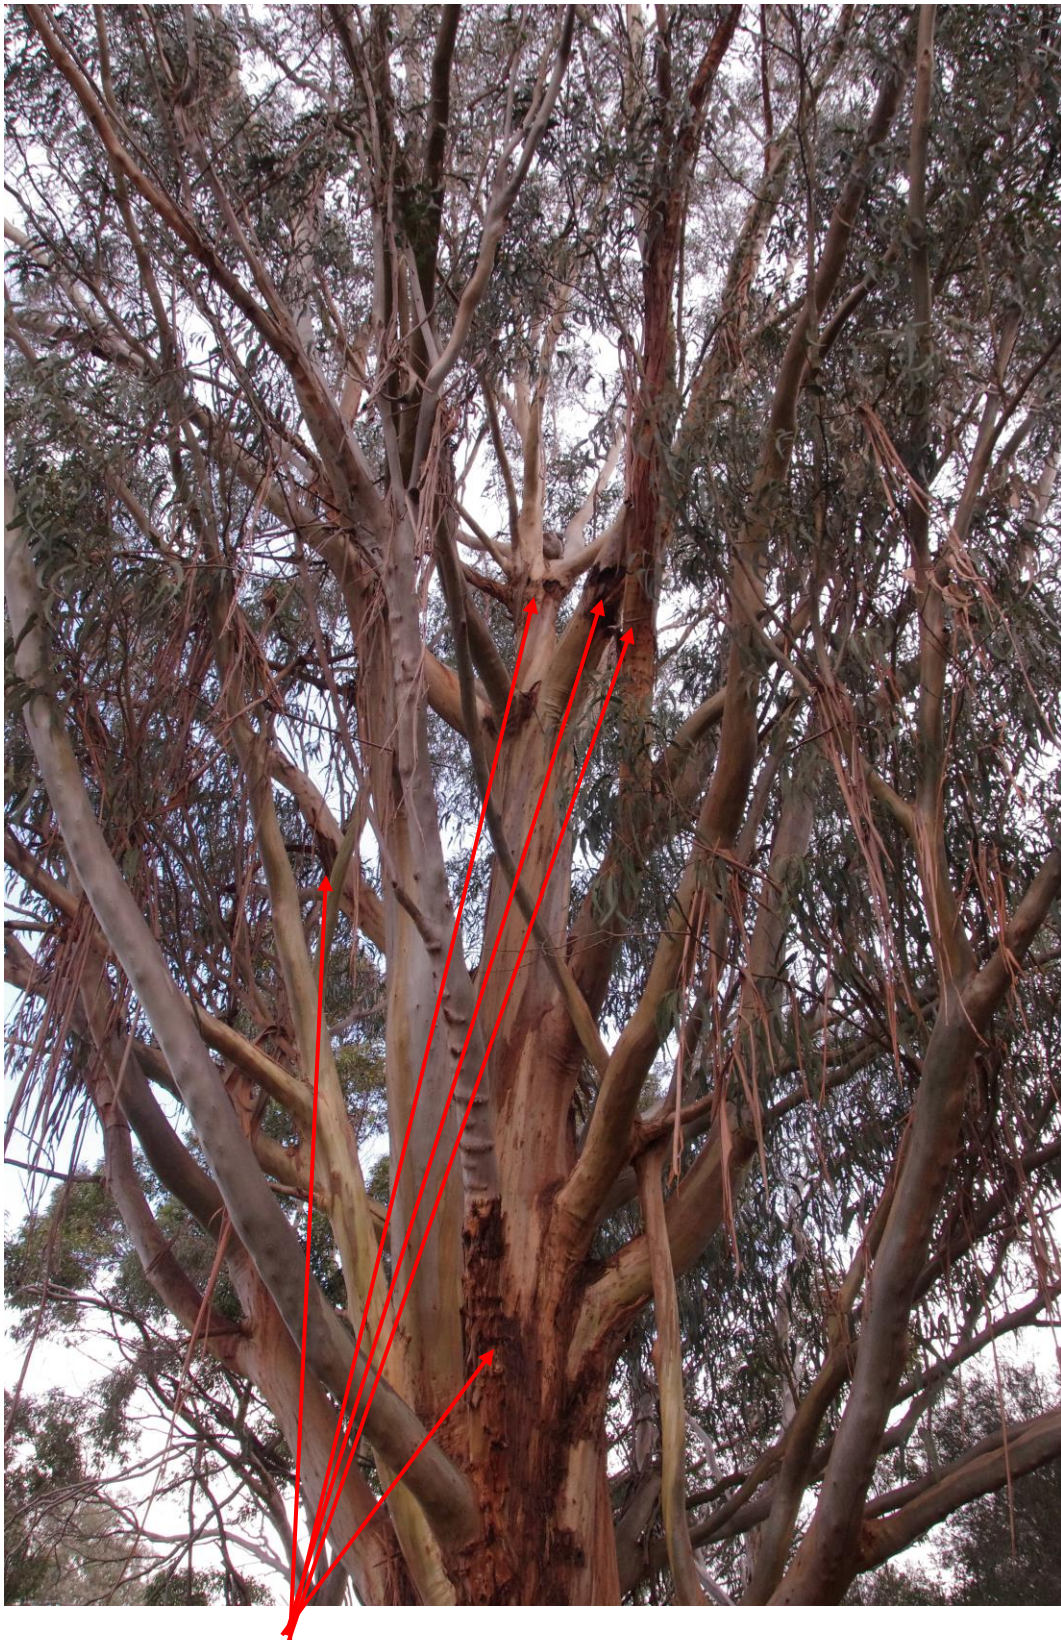
Tree # 15, Borer activity areas (there was a Koala in the top)

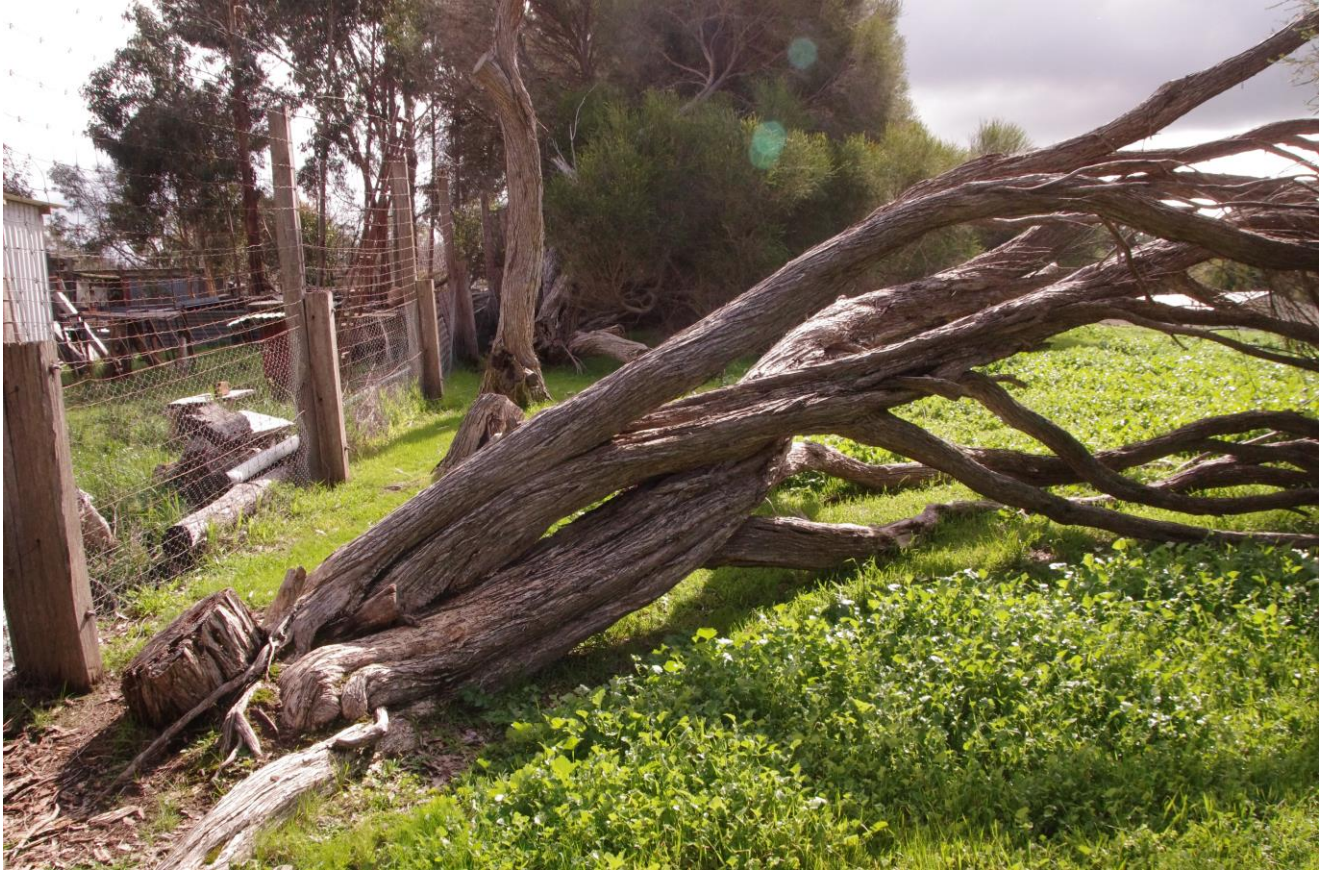
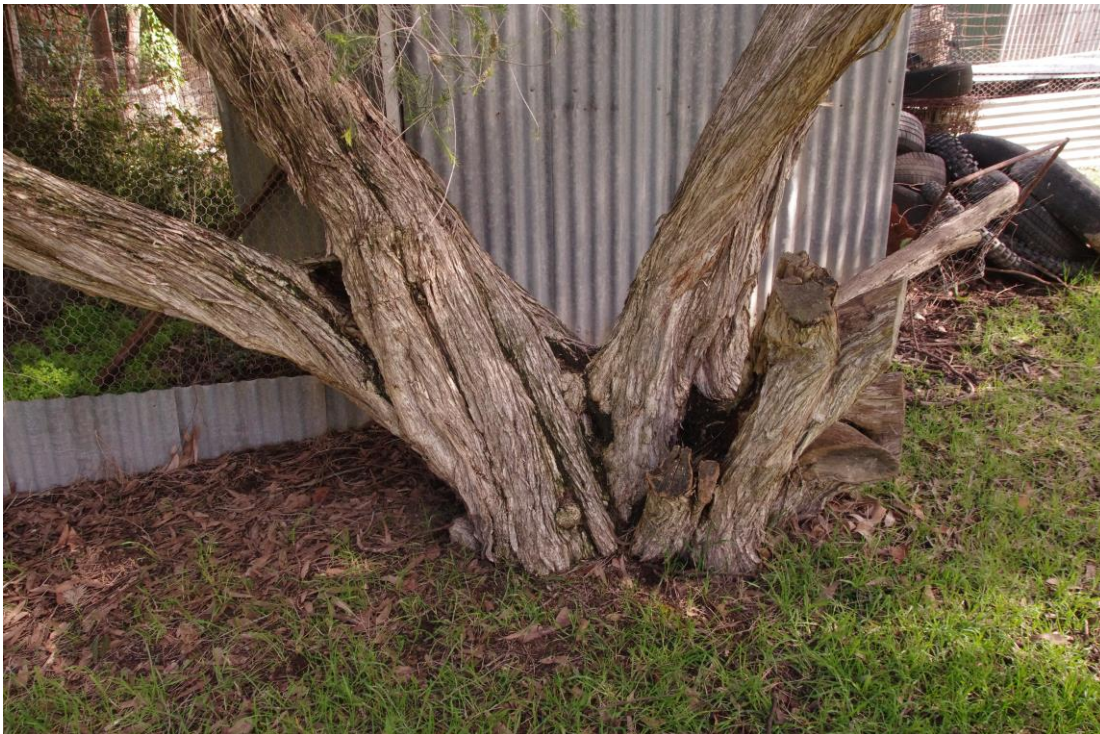
Condition of various Melaleuca's

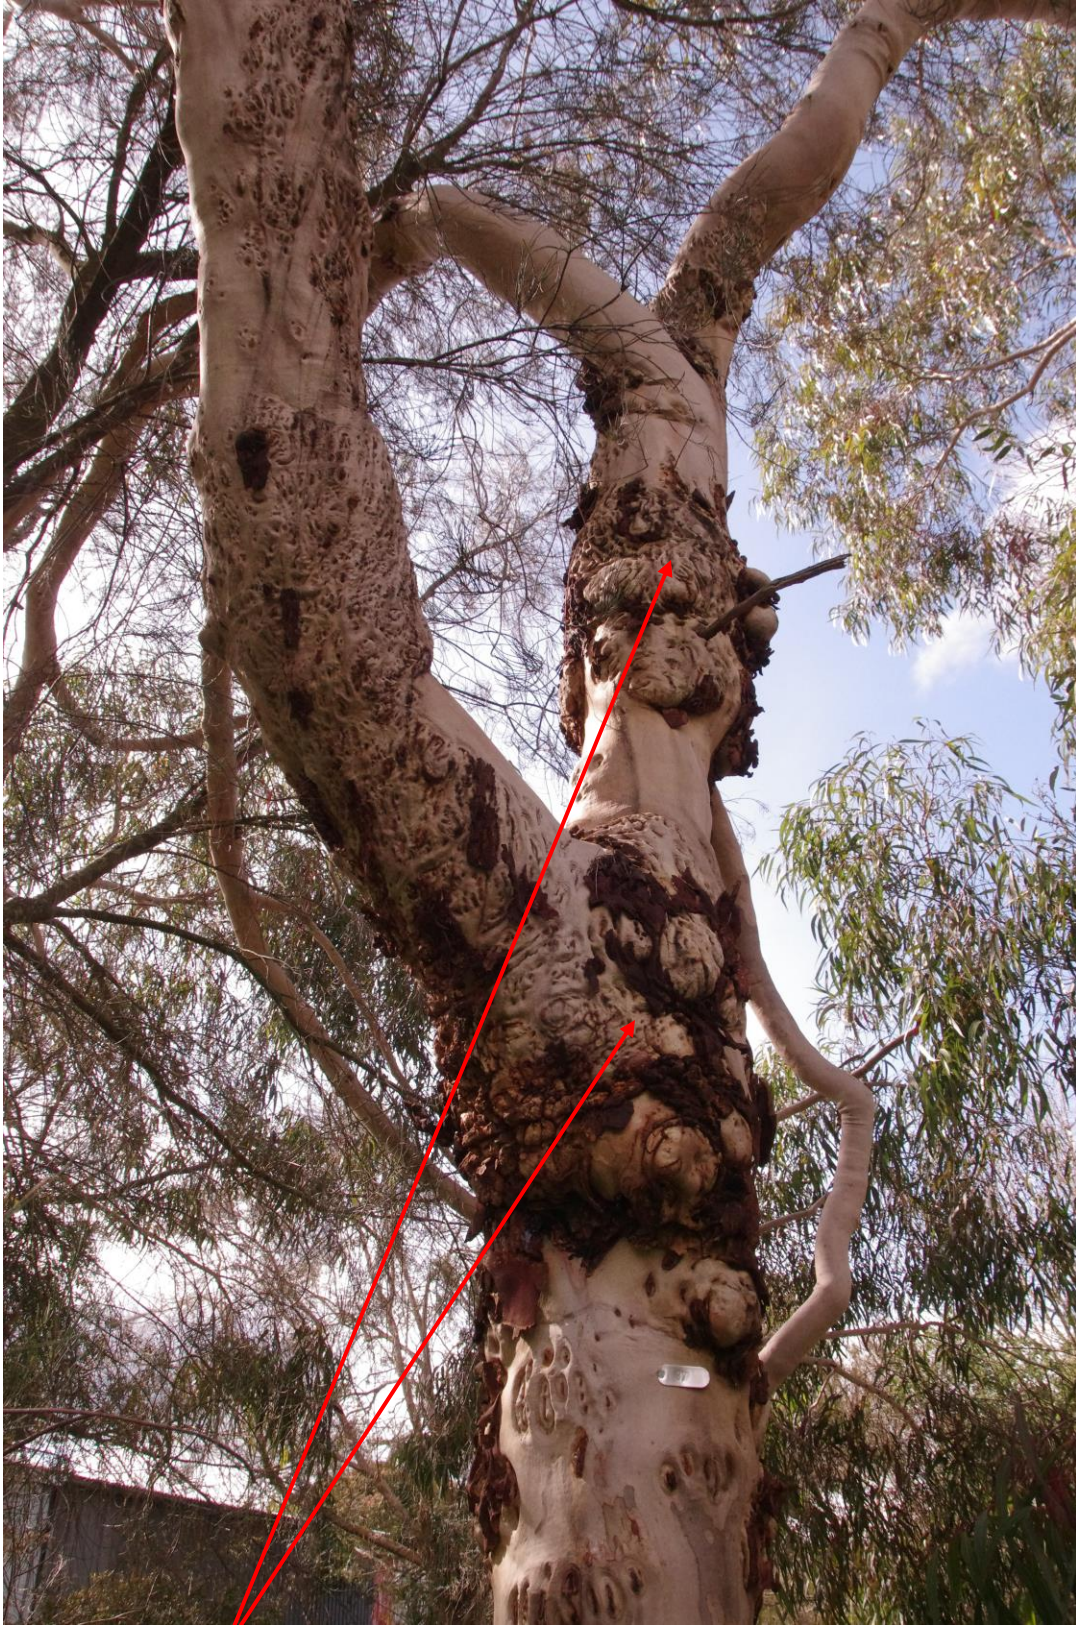
Tree # 37 Diseased

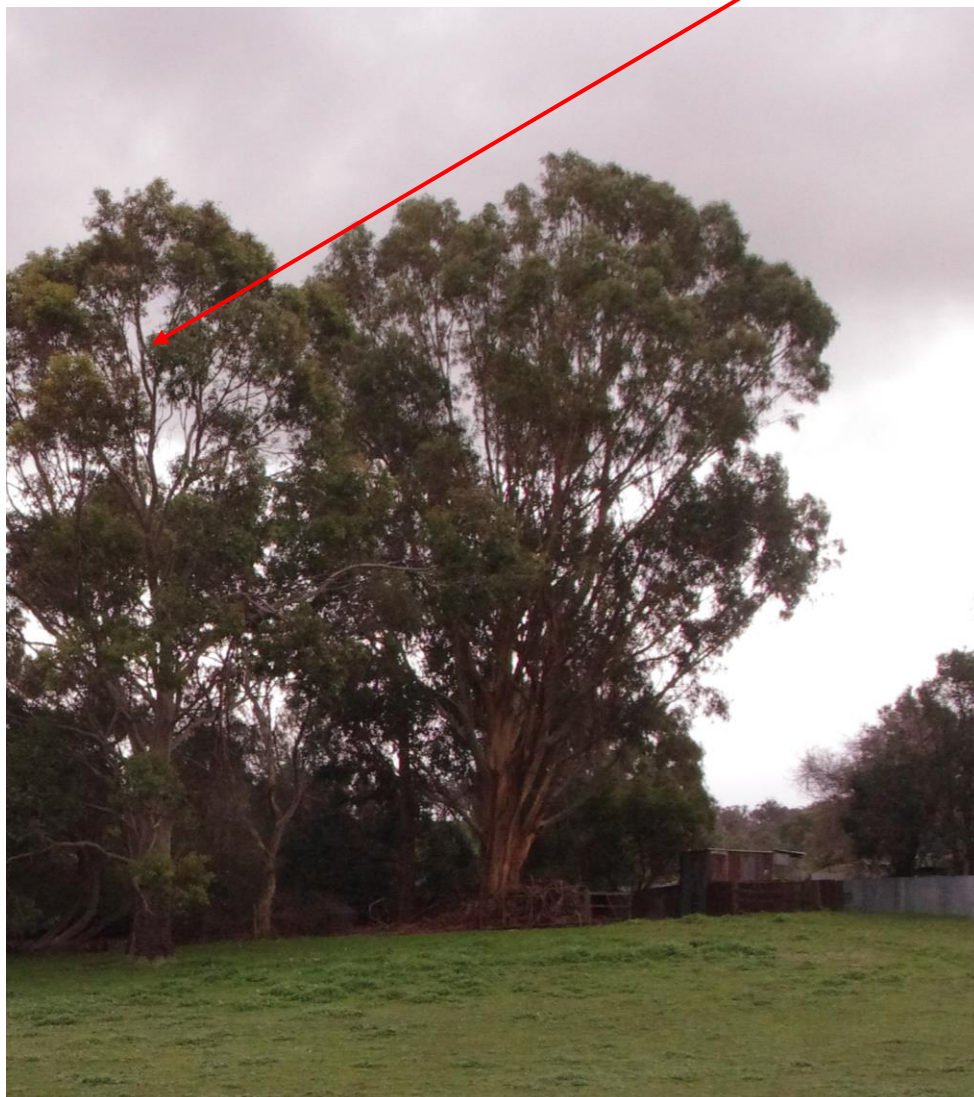
Tree species: *Corymbia citrodora* (Lemon-scented Gum) Number 14 tagged

Height of tree: Approximately 18.2m.

Current condition: The tree is in an average to healthy condition with little or no maintenance work carried out on this tree. There is major deadwood and broken branches throughout the canopy.

- Remove wire around trunk, remove all deadwood and retrim broken branches. (short term solution)
- As the tree is in an average condition and if development was intrusive to the TPZ this could possibly cause the tree to stress, causing more major branches to fail and for the decline in health within 5 to 10 years. This would escalate the potential consequence to a severe rating.

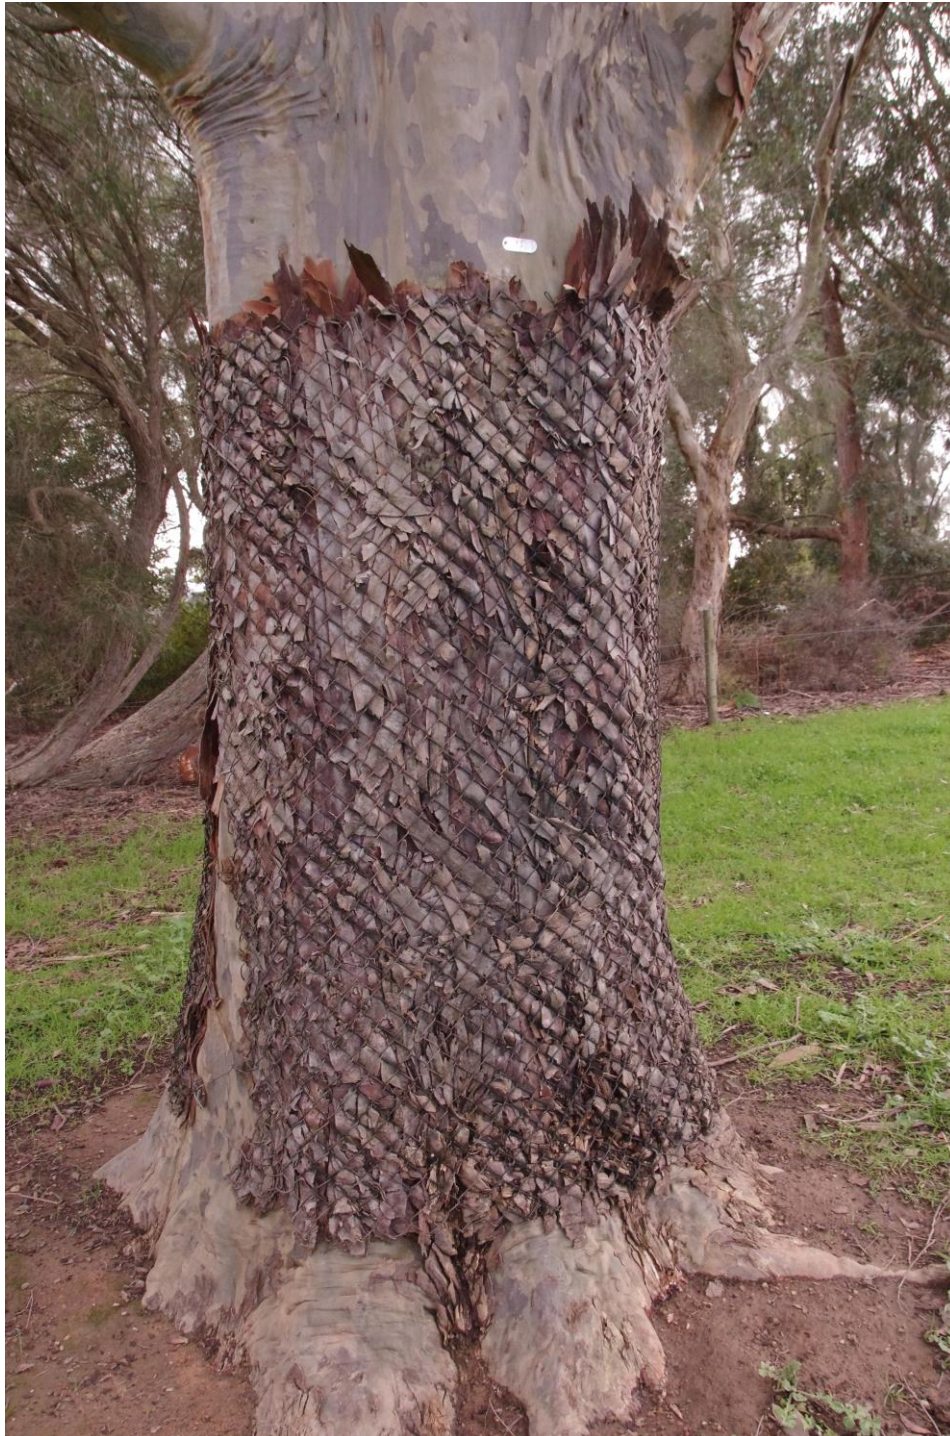
Trunk integrity: The main trunk is sound but has had wire wrapped around it.

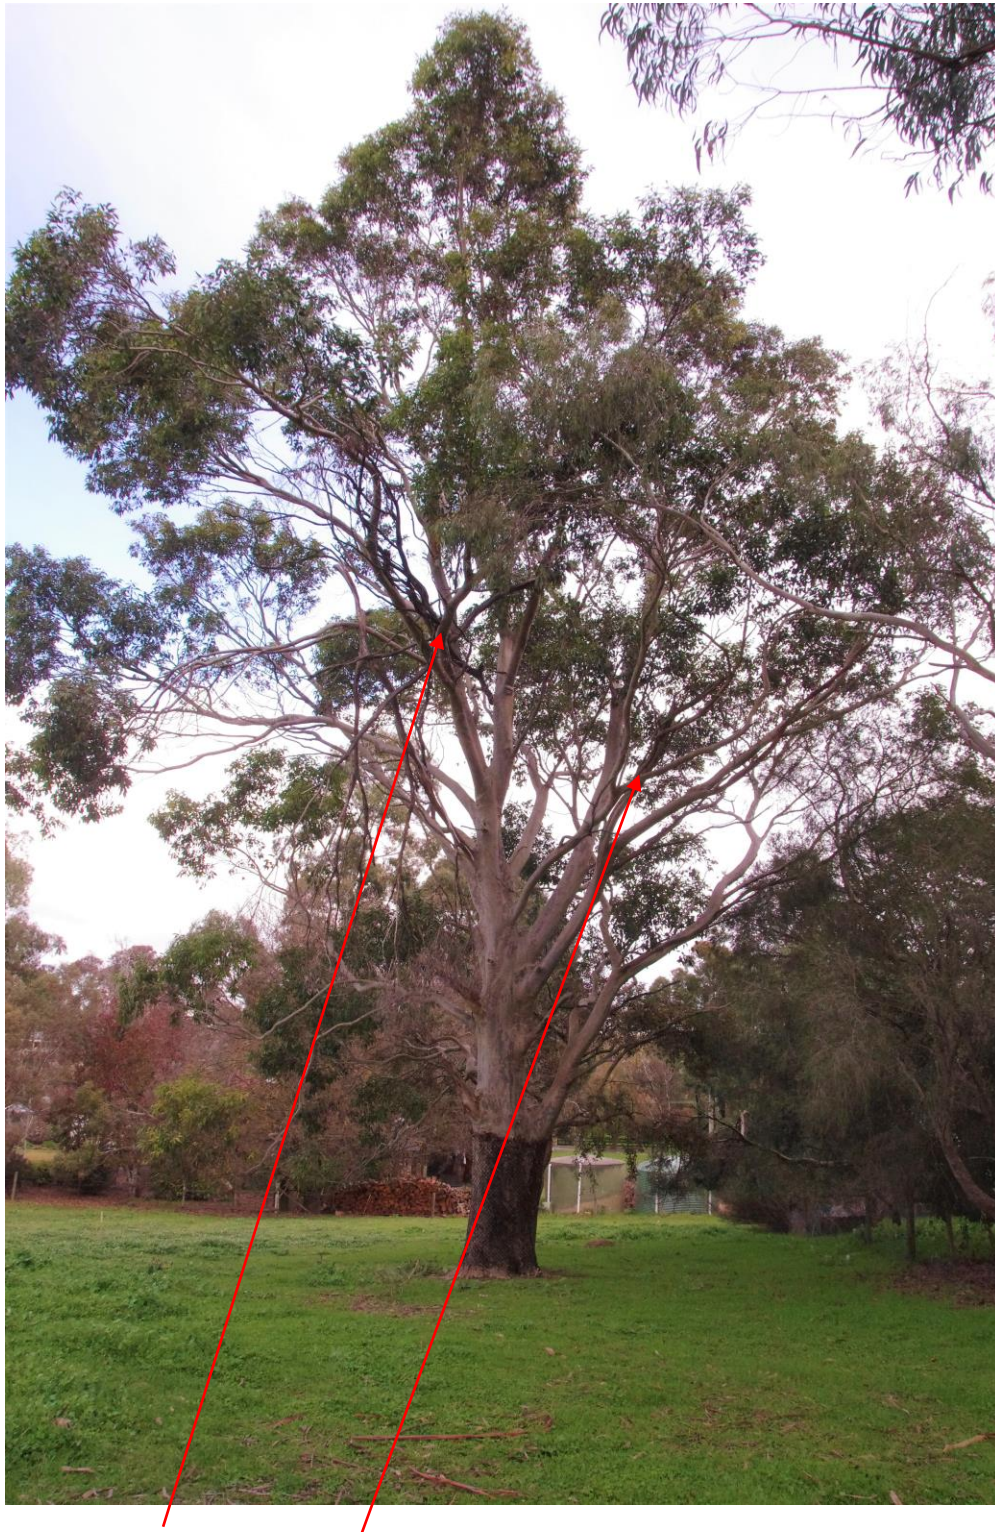
Branch integrity: The majority of branches are in an average condition with broken branches and deadwood throughout the canopy. There has been signs of major branch failures. Integrity would be average.

Broken branches and deadwood

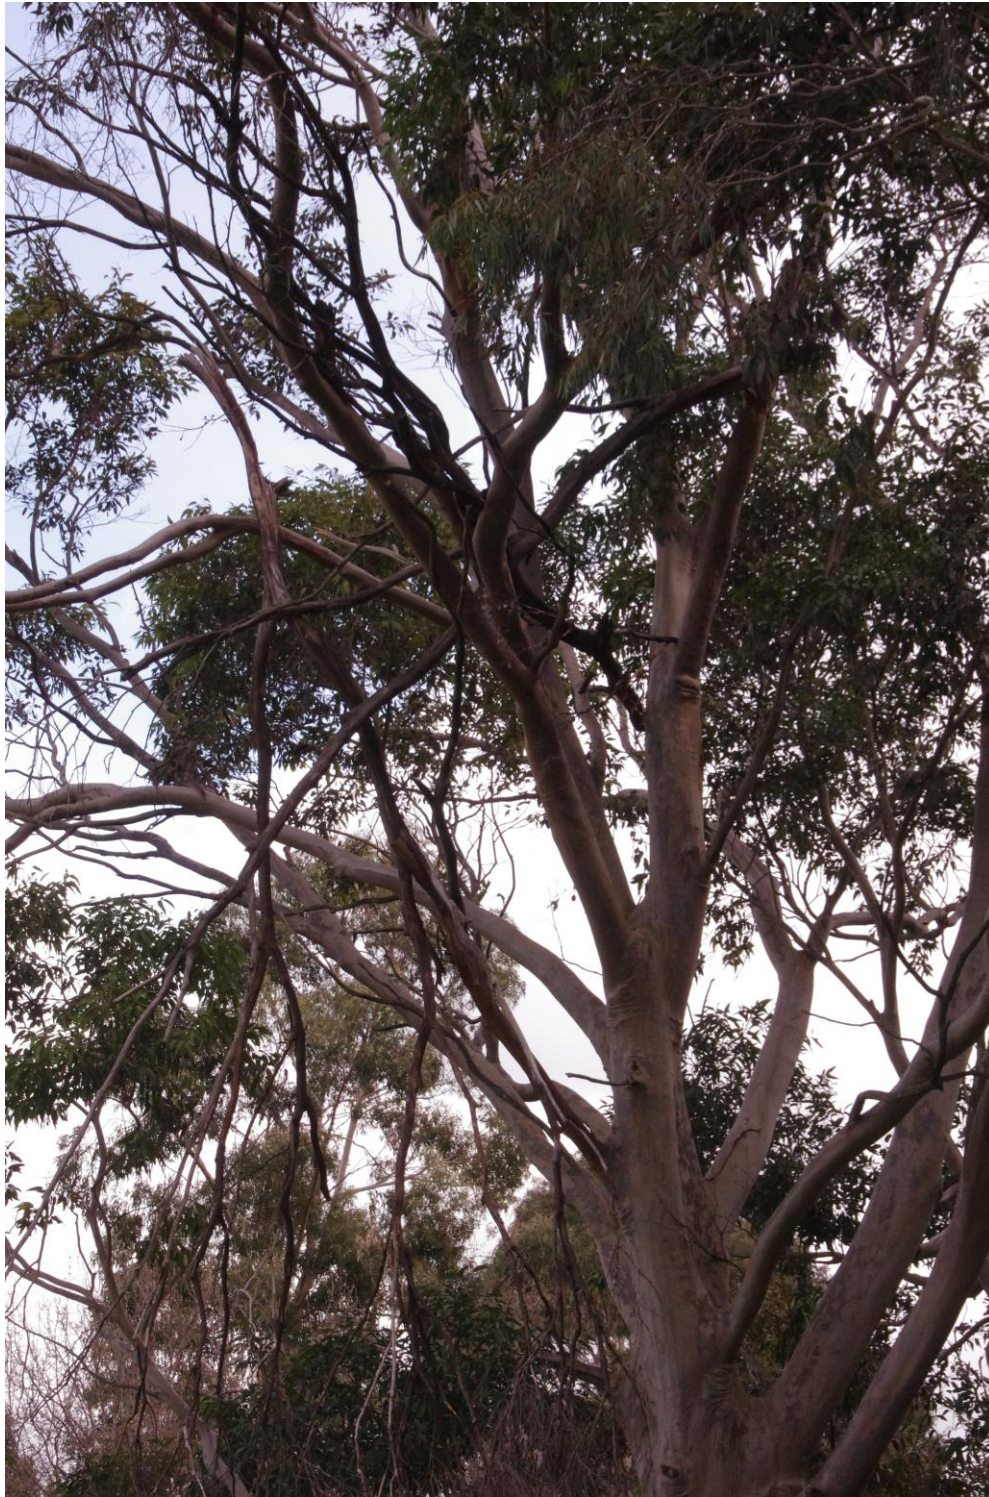
Presence of swollen areas: Included bark unions.

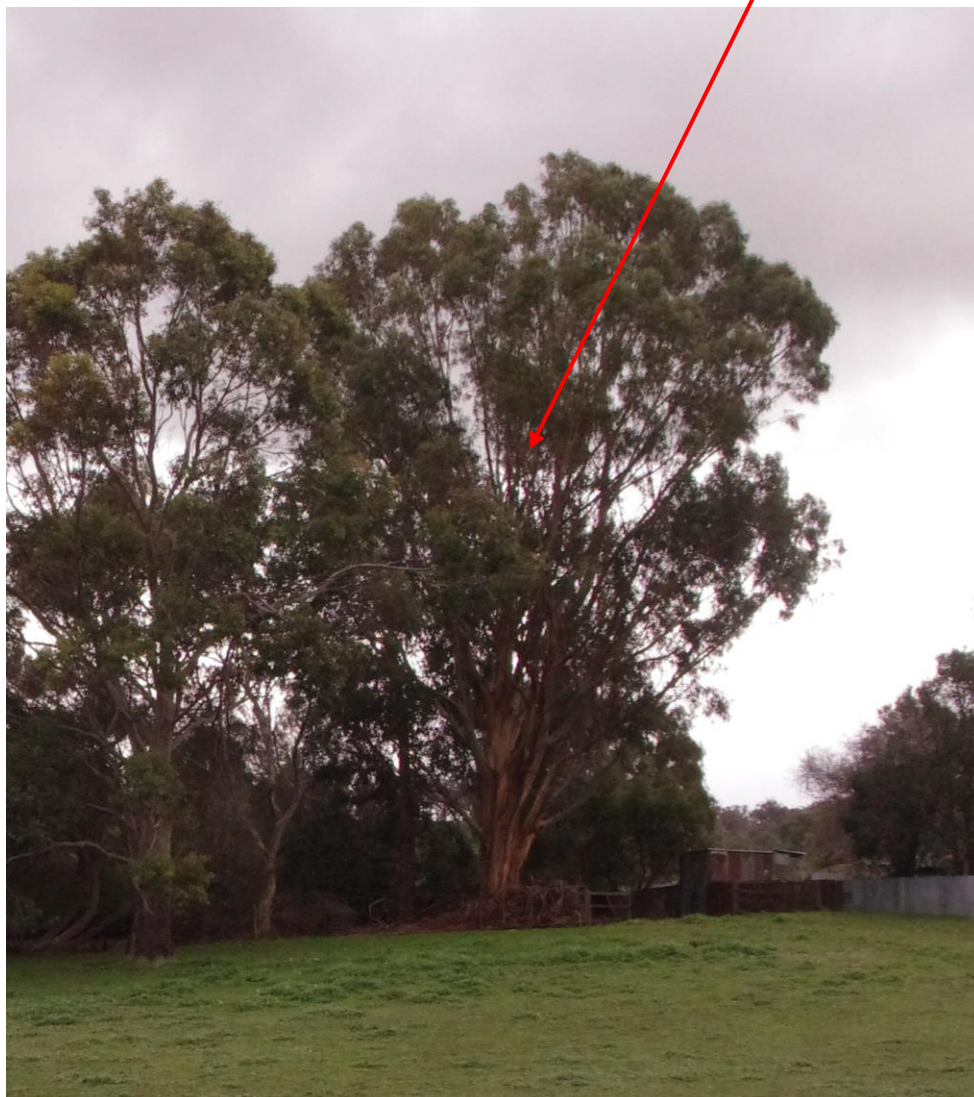
Tree species: Eucalyptus globulus (Tasmanian Blue Gum) Number 15 tagged

Height of tree: Approximately 22m.

Circumference 1m above ground level: 3.87m (Significant tree).

Location of tree: Centre of allotment, west of number 18 Fricks Street

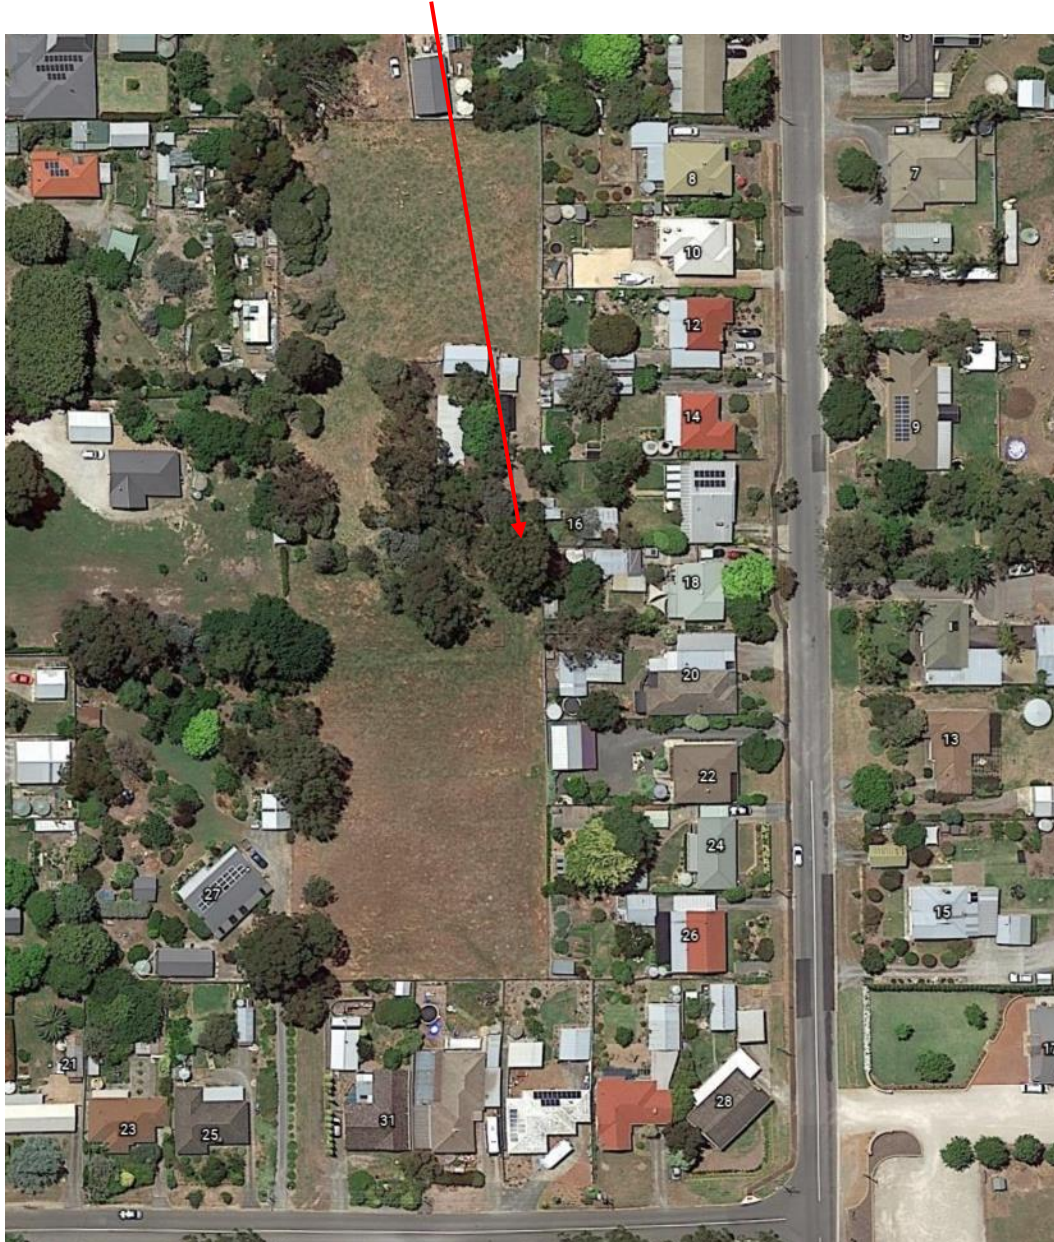
Current condition: The tree is in an average condition with little or no maintenance work carried out on this tree. There is major borer activity throughout the trees structure which is starting to affect the foliage with minor die-back and thinning canopy.

Trunk integrity: The main trunk has many long lateral branches and borer activity in many locations.

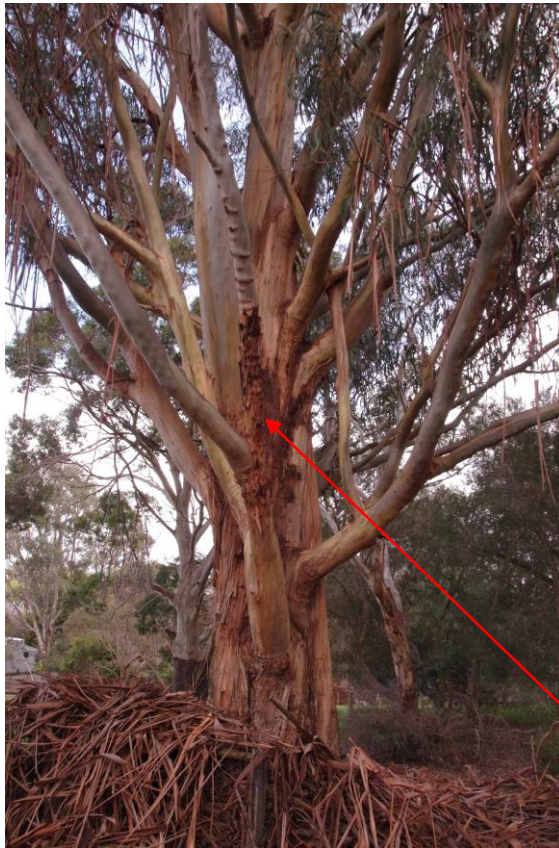
Borer activity

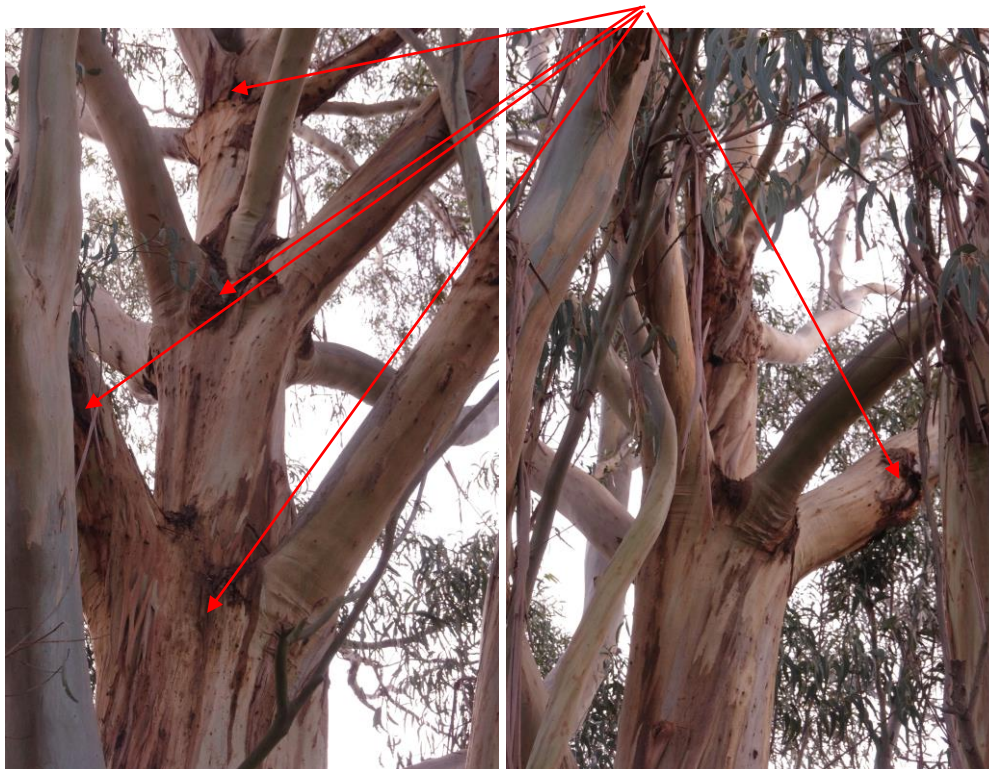
Branch integrity: The majority of branches are in an average condition with included bark unions, borer activity and deadwood throughout the canopy. There has been no signs of major branch failure as yet but could be expected. Integrity would be average.

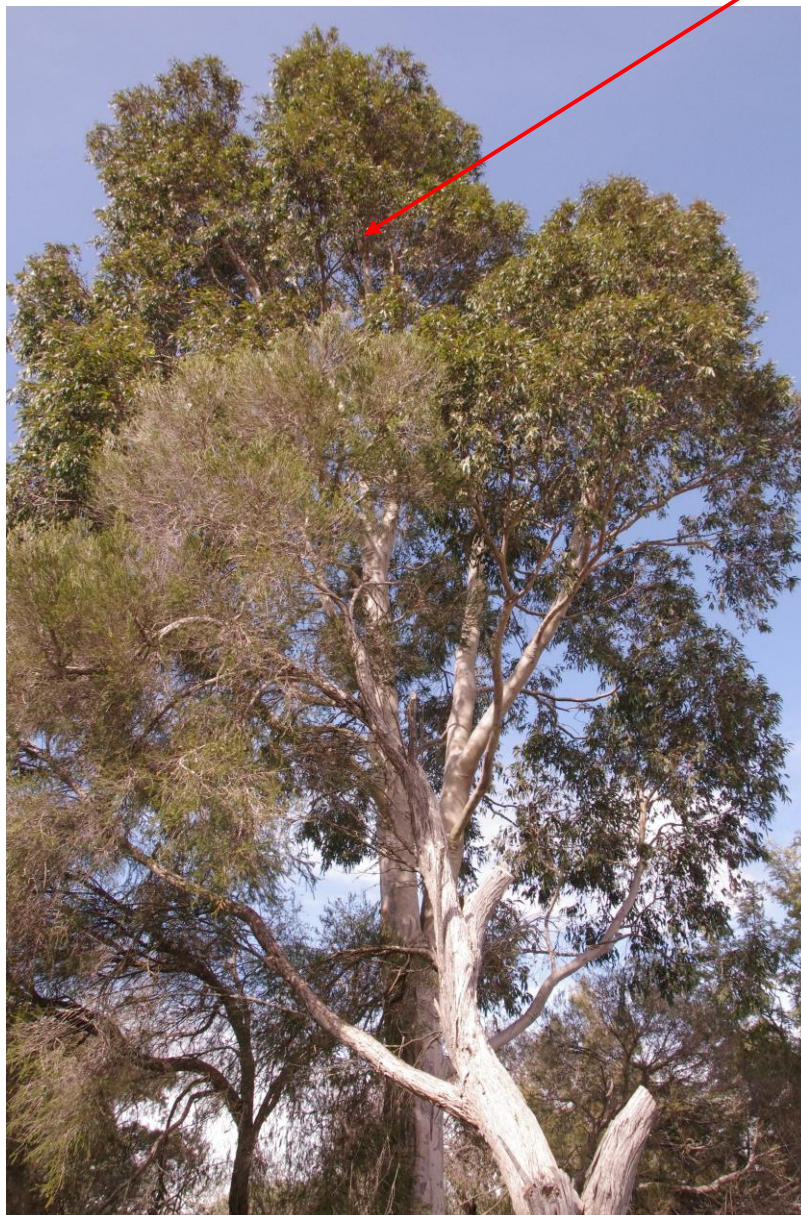
Tree species: *Corymbia citrodora* (Lemon-scented Gum) Number 24 tagged

Height of tree: Approximately 20.2m.

Location of tree: Western boundary of allotment, west of number 18 Fricks Street
