COUNCIL ASSESSMENT PANEL MEETING

AGENDA – 8.4

Applicant: Kermel Pty Ltd	Landowner: Kermel Pty Ltd
Agent: Greg Burgess - Access SDM	Originating Officer: Ashleigh Gade
Development Application:	20/1058/473 (20/C047/473)
Application Description: Community title division (1 into 11), removal of 1 regulated tree (<i>Corymbia citriodora</i> – Lemon-scented gum) & 2 significant trees (<i>Corymbia citriodora</i> – Lemon-scented gum & <i>Eucalyptus globulus</i> – Tasmanian blue gum) & construction of internal roadway	
Subject Land: Lot Lot:45 Sec: P5126 DP:125856 CT:6249/801 (formerly Lot:54 Sec: P5126 FP:155869 CT:5491/250)	General Location: 29 Kumnick Street, Lobethal SA 5241 Attachment – Locality Plan
Development Plan Consolidated: 8 August 2019. Map AdHi/12	Zone/Policy Area: Township Zone - Township (Lobethal) Policy Area
Form of Development: Merit	Site Area: 1.066 hectares
Public Notice Category: Category 1 Merit -	Representations Received: N/A Representations to be Heard: N/A

The purpose of this application is to create eleven (11) community titled allotments. The proposal includes the removal of one (1) regulated tree (*Corymbia citriodora* – Lemon-scented gum) and two (2) signific

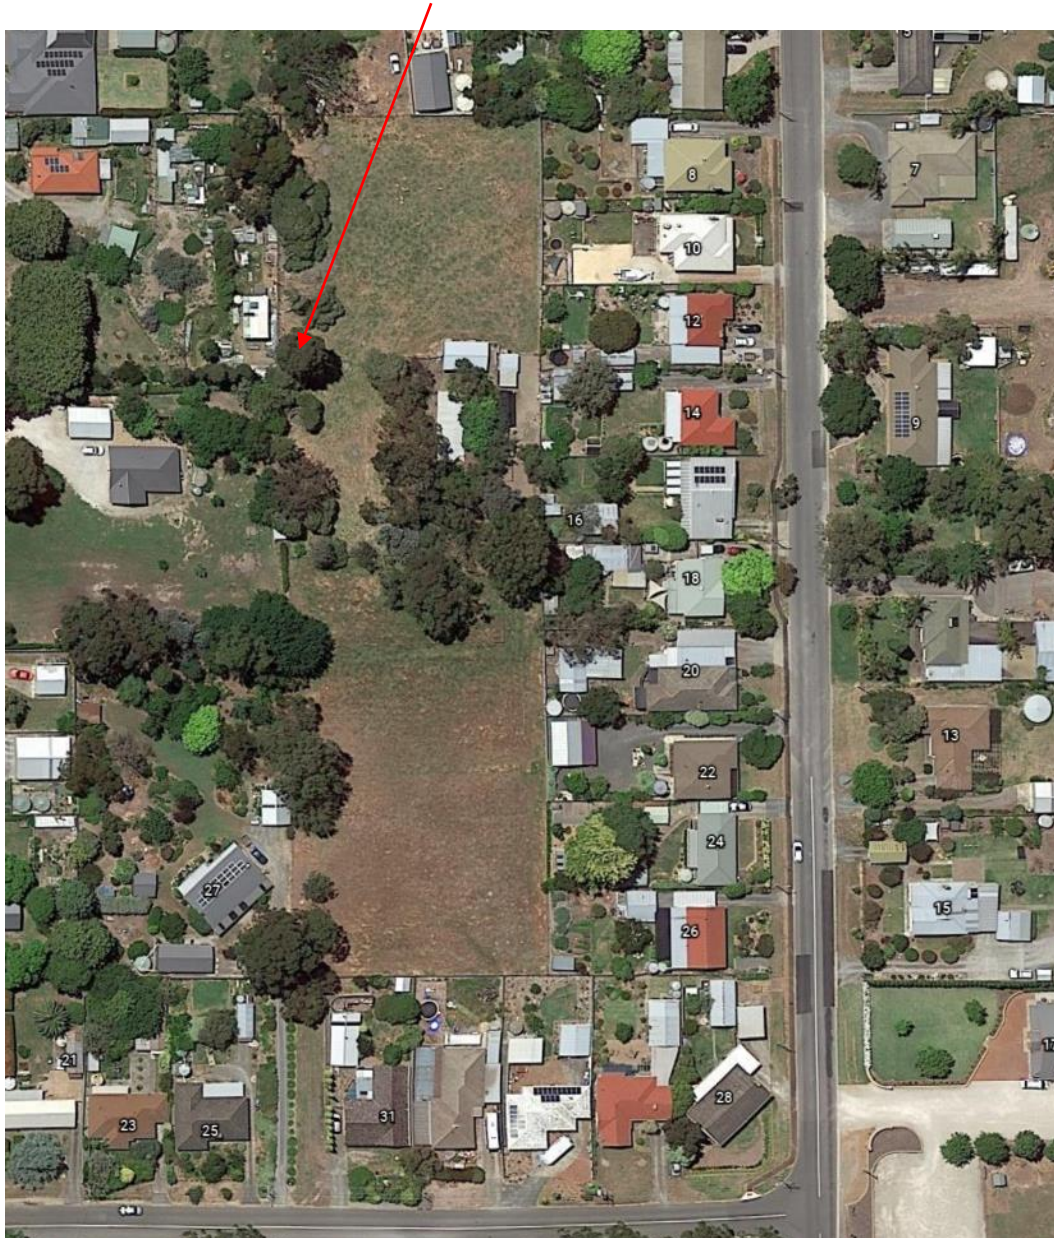
Current condition: The tree is in an average to healthy condition with little or no maintenance work carried out on this tree. There is major structural defect within the canopy. (Included bark union with swelling and possible decay within the union).

Trunk integrity: The main trunk is sound at present but has a major structural defect, approximately 8m above ground level with an included bark union, swelling and possibly decay within this area.

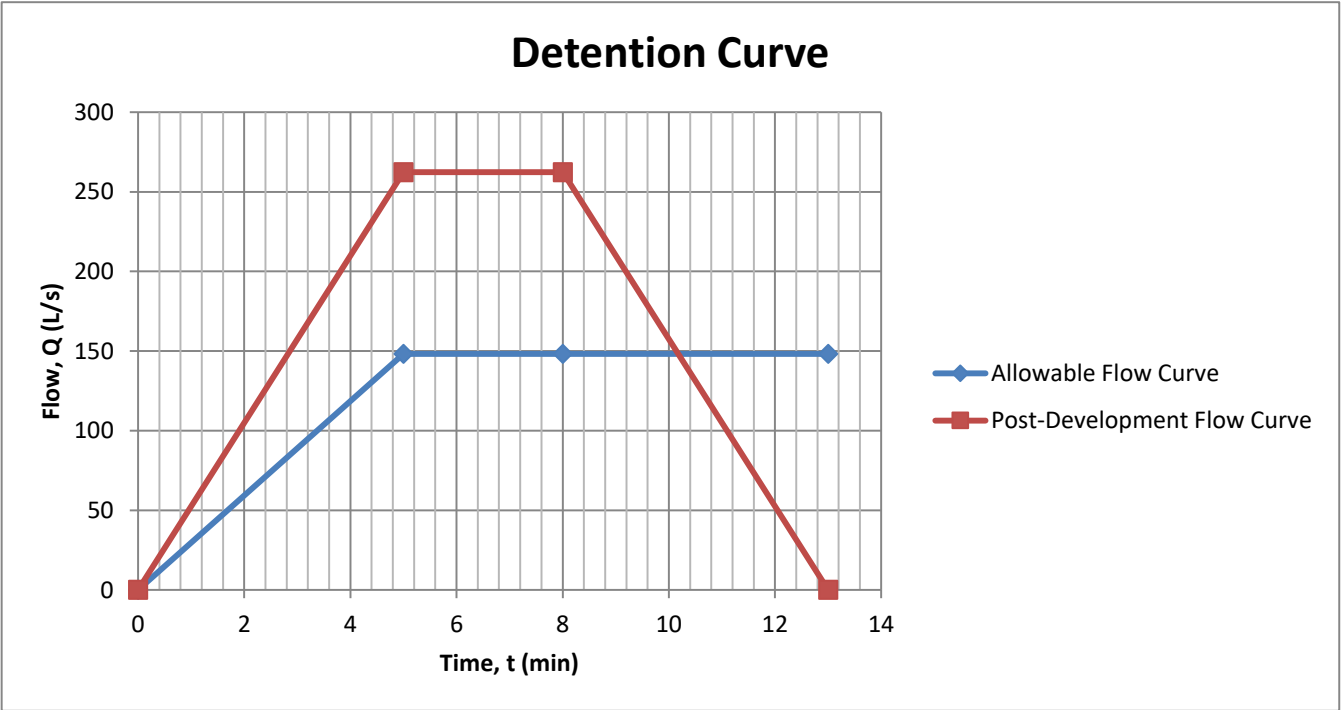
Detention Curve Data - Detention volume equal to area between curves

Allowable Flow Curve		Post-Development Flow Curve	
Time (min)	Flow (L/s)	Time (min)	Flow (L/s)
0	0	0	0
5	148.20	5	262.34
8	148.20	8	262.34
13	148.20	13	0

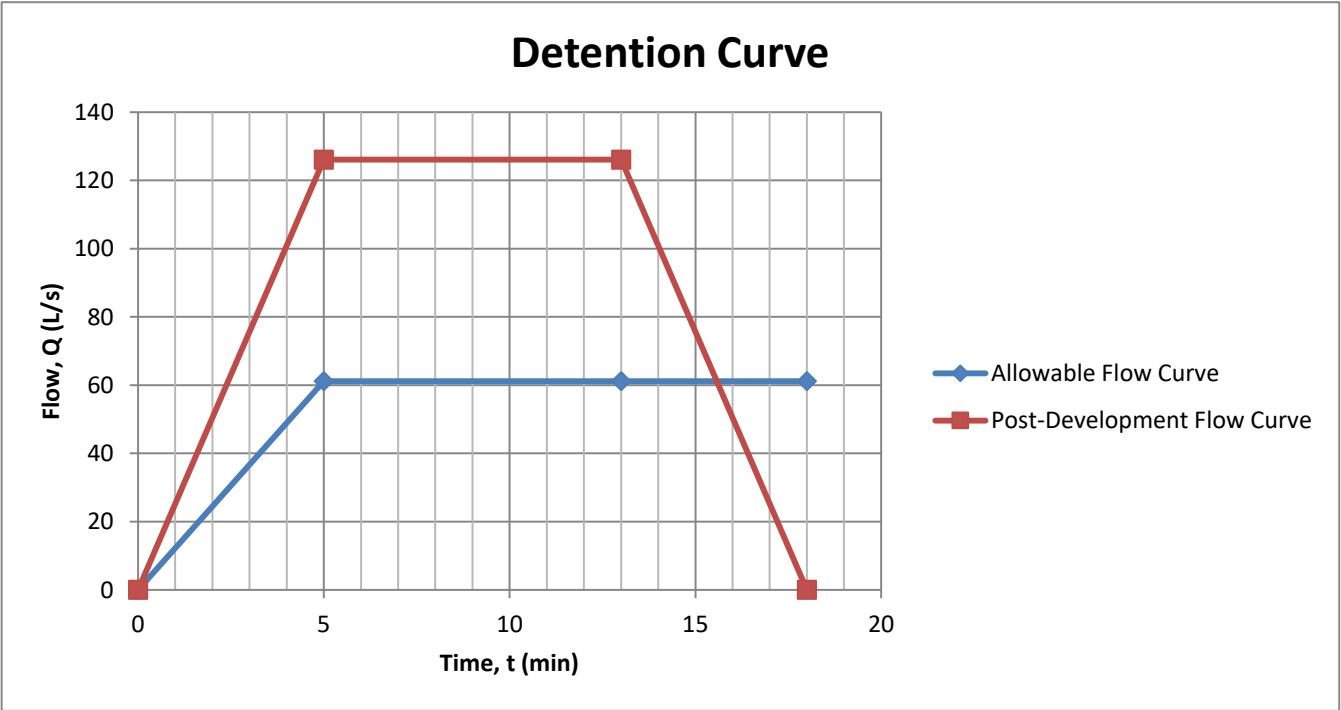
Detention Curve Data - Detention volume equal to area between curves

Allowable Flow Curve		Post-Development Flow Curve	
Time (min)	Flow (L/s)	Time (min)	Flow (L/s)
0	0	0	0
5	61.15	5	126.10
13	61.15	13	126.10
18	61.15	18	0

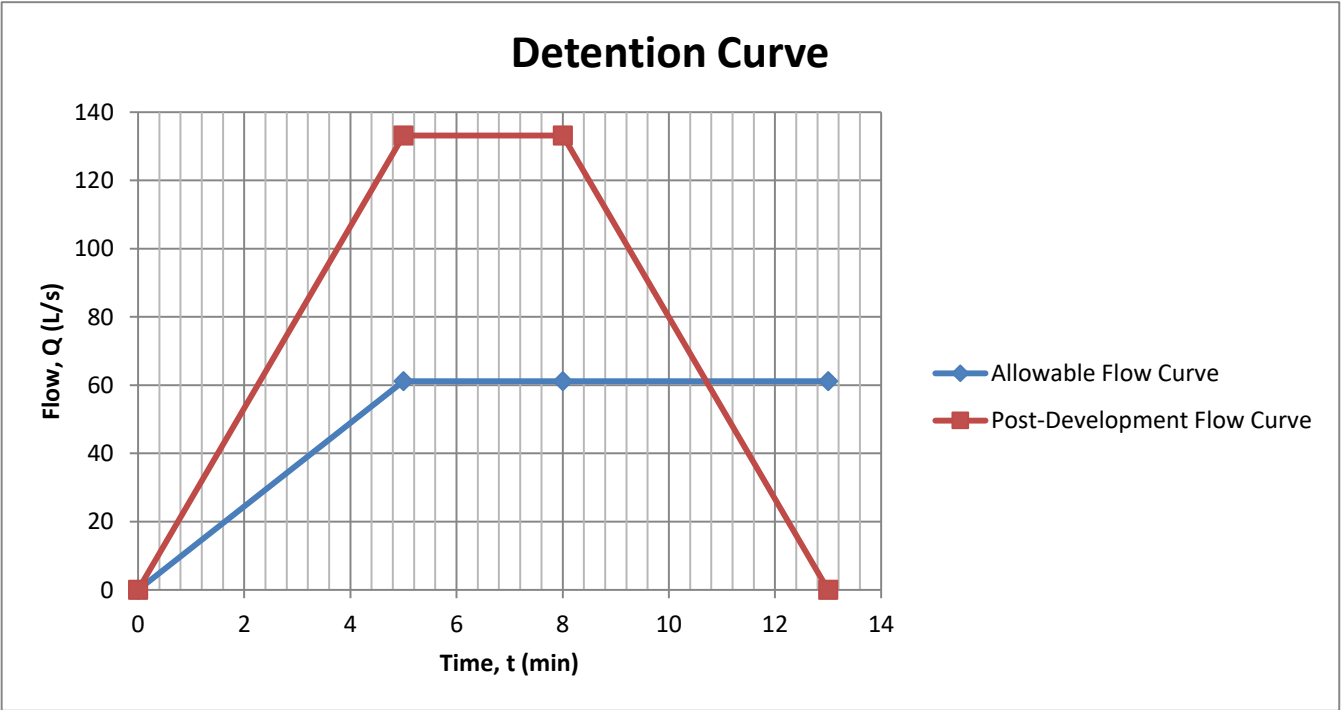
Detention Curve Data - *Detention volume equal to area between curves*

Allowable Flow Curve		Post-Development Flow Curve	
Time (min)	Flow (L/s)	Time (min)	Flow (L/s)
0	0	0	0
5	61.15	5	133.16
8	61.15	8	133.16
13	61.15	13	0

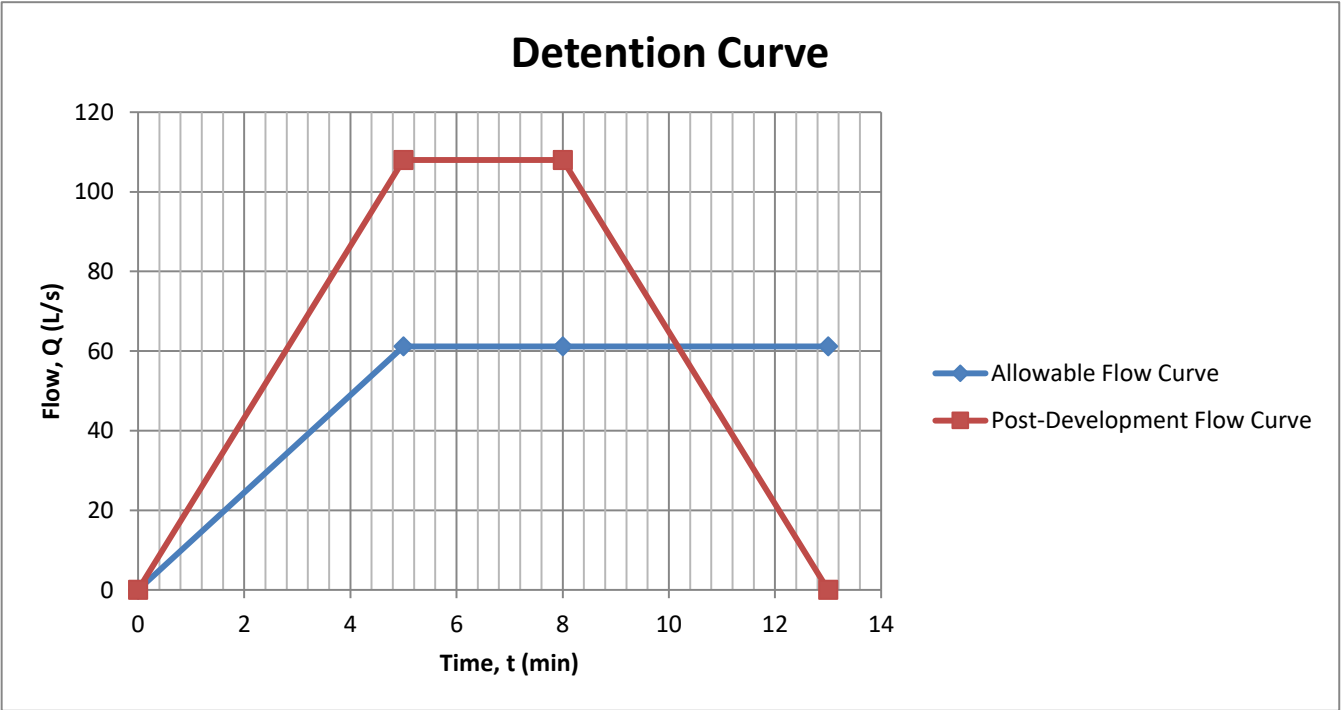
Detention Curve Data - Detention volume equal to area between curves

Allowable Flow Curve		Post-Development Flow Curve	
Time (min)	Flow (L/s)	Time (min)	Flow (L/s)
0	0	0	0
5	61.15	5	107.99
8	61.15	8	107.99
13	61.15	13	0

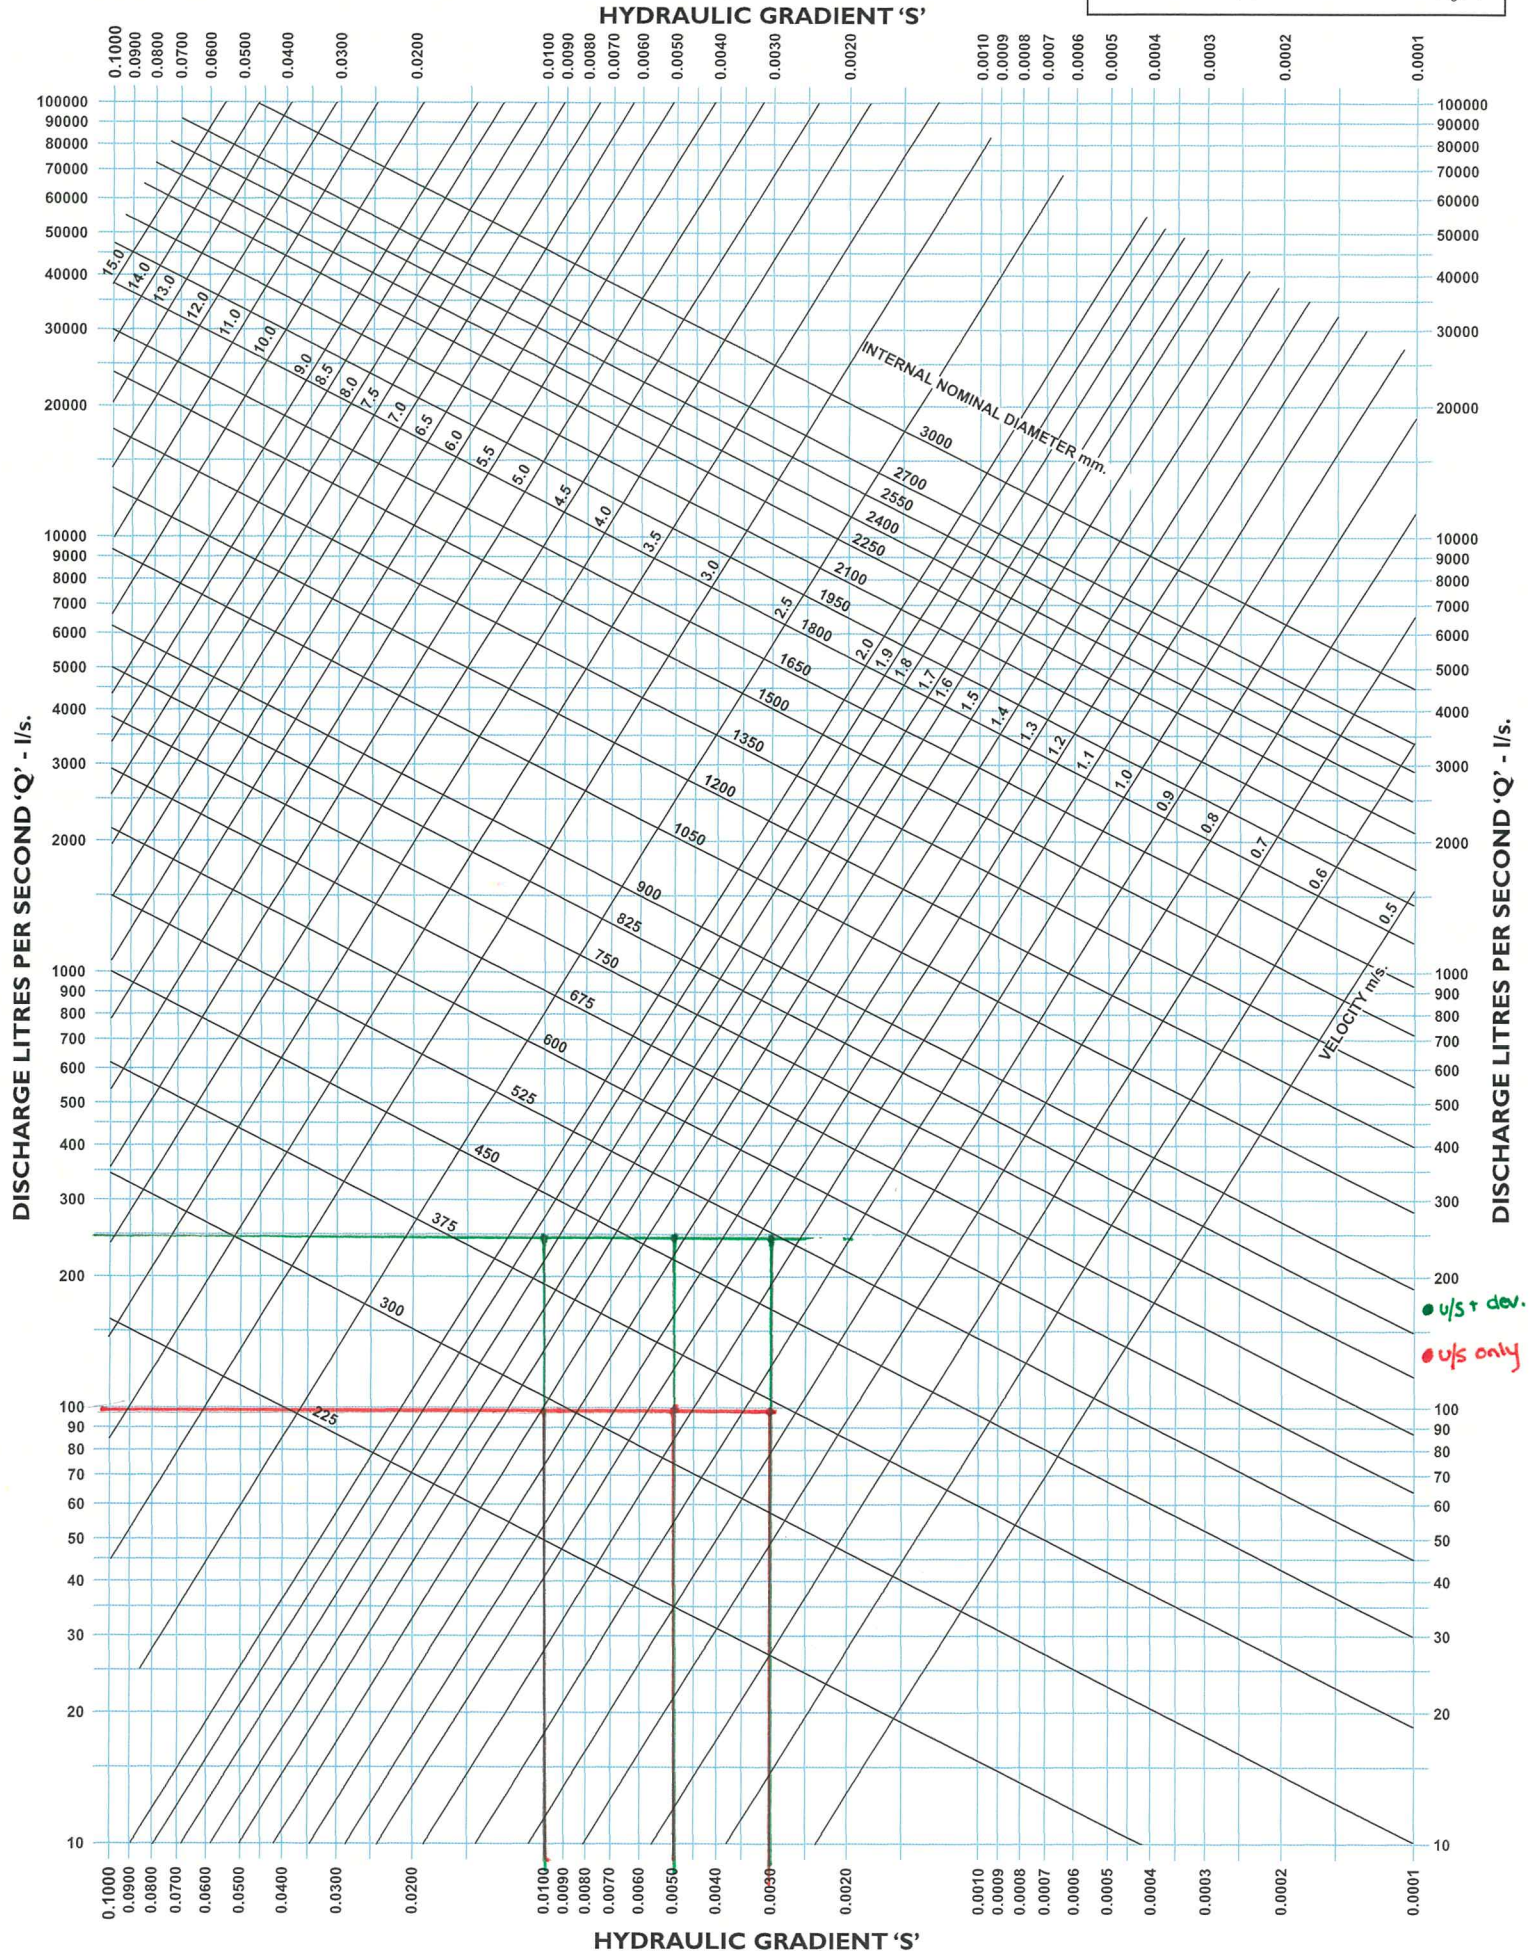
HYDRAULIC GRADIENT 'S'

For circular pipes running full
but not under head.

$$\text{Computed by: } \frac{1}{\sqrt{f}} = -2\log_{10}\left(\frac{k}{3.7D} + \frac{2.51}{R_e\sqrt{f}}\right)$$
